# ANALYTICAL AND FIELD EVIDENCE OF THE DAMAGING EFFECT OF VERTICAL EARTHQUAKE GROUND MOTION

## SUMMARY

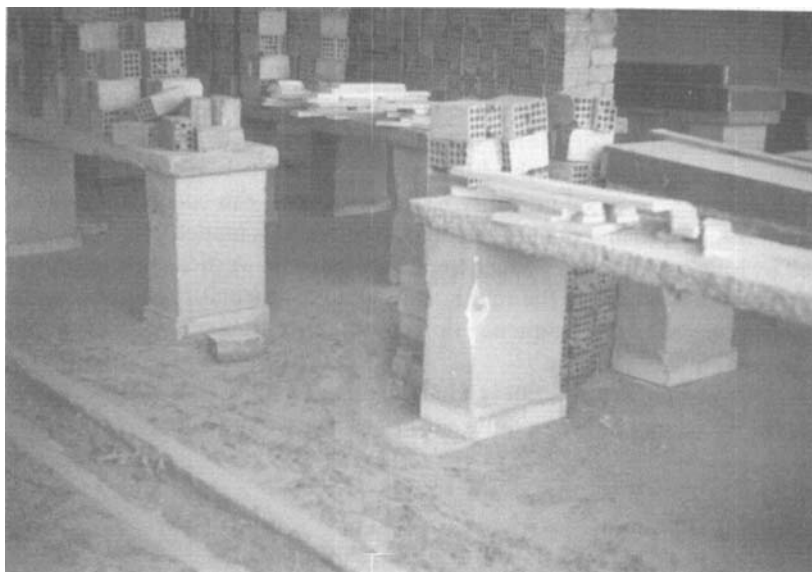
Figure 1. Evidence of strong vertical motion. A bench which has displaced horizontally without friction at the interface

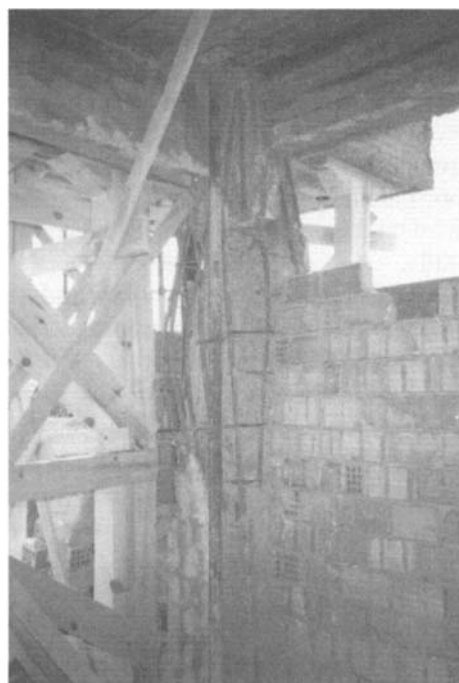
Figure 2. Compressive column failure in a residential building in Kalamata. The presence of the incomplete infill panel did not induce shear failure in short column

In terms of structural damage inflicted on RC buildings, Elnashai *et al.*<sup>6-8</sup> report an unusually high number of symmetric compression and shear-compression failures in columns and shear walls, as opposed to bending failures. Such failures are even observed in buildings with a soft ground storey where bending failure is naturally expected. Although many of these can be attributed to poor detailing and construction errors, it is suspected that the strong vertical component also played a significant role. It is considered that the

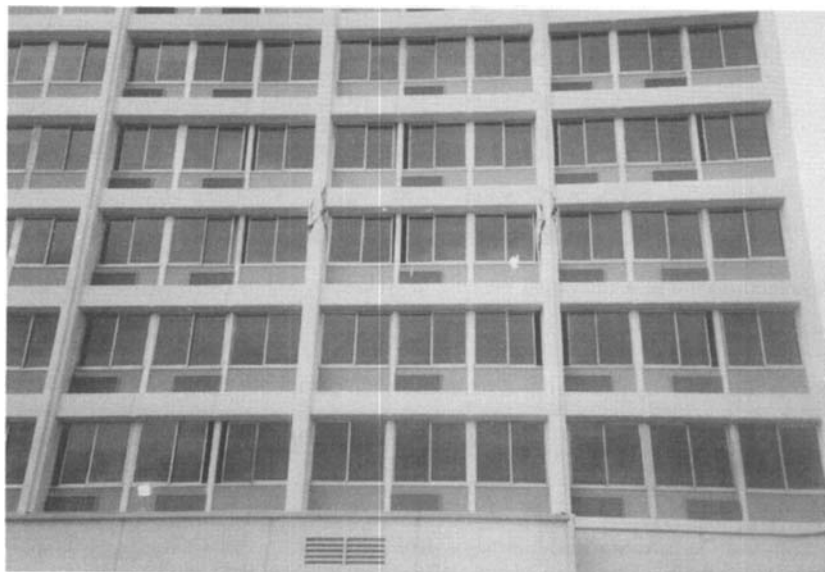
Figure 3. Shear-bond splitting failure in 3rd storey of Holiday Inn Hotel in Van Nuys

Of instrumented buildings closest to the epicentre the Holiday Inn Hotel in Van Nuys was located approximately 7 km east of the epicentre. This 7-storey RC frame experienced a peak horizontal acceleration of 0.47 g and a peak vertical acceleration of 0.30 g at the base which resulted in serious structural damage in several columns of the third floor,<sup>9</sup> as shown in Figure 3. The maximum recorded horizontal acceleration at the roof was 0.59 g, i.e. an amplification of only 1.25. Inspection of the acceleration time-histories recorded in the building verified that they are all in phase, hence indicating first mode response in the horizontal direction. Moreover, the same records show that no torsional response took place.<sup>9</sup> Therefore, there is very high probability that the shear-bond splitting failure which was only observed in the third storey was induced by a reduction of shear capacity due to vertical motion, as explained previously. It is here appropriate to note that for first mode vertical response the reduction of axial force in columns or walls is more profound for higher storeys, since it represents a larger relative change of the pre-existing static axial load. Hence, a larger instantaneous reduction of column shear capacity is expected for upper floors. This, combined with higher shear force demand in lower storeys justifies the intermediate storey failure observed.

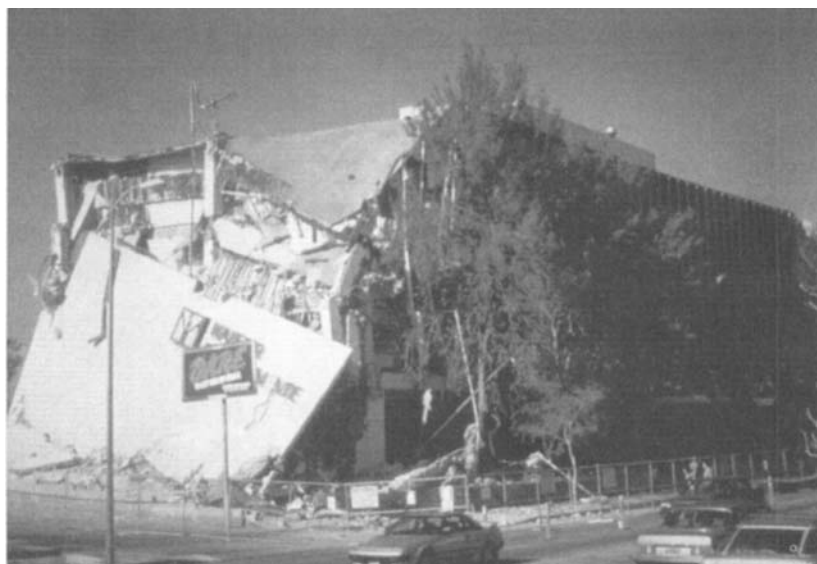
Figure 4. Second storey collapse of Kaiser Permanente building in Balboa Boulevard at Northridge. Photograph courtesy of Earthquake Engineering Research Institute

An example of intermediate storey failure which resulted in collapse was the case of the Kaiser Permanente administrative building situated on the Balboa Boulevard in Northridge. The 5-storey mixed wall-frame RC building lost the entire second storey due to shear failure of the columns and beam-column joints. This is shown in Figure 4. In addition, poor detailing in the beam-column joints lead to complete collapse.<sup>9</sup> The detrimental effect of reduced axial load on the ductility and shear capacity of RC joints is a known fact which has been demonstrated experimentally.<sup>12</sup>

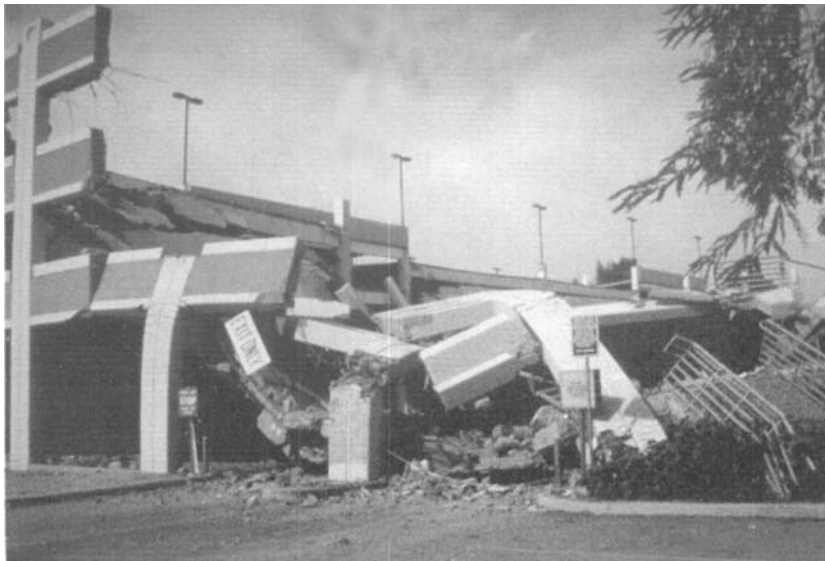
Figure 5. Collapsed CSUN parking structure. The perimeter frame does not show signs of distress where gravity system has not failed. Photograph courtesy of Earthquake Engineering Research Institute

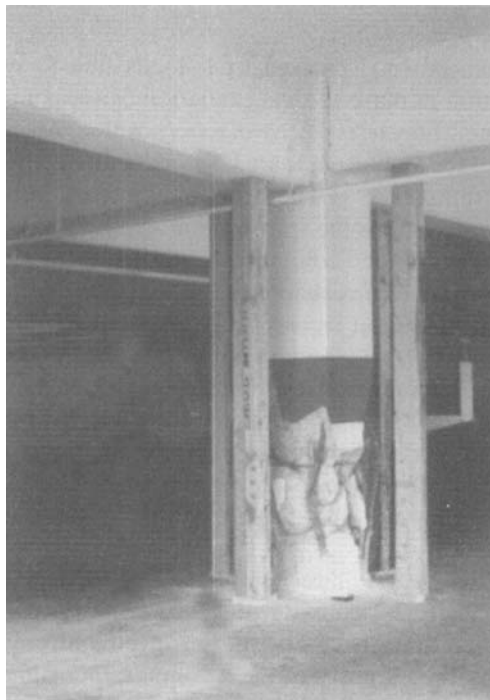
Figure 6. Shear-compression failure in column of cast-in-place garage in Sherman Oaks. Photograph courtesy of National Center for Earthquake Engineering Research

their design is not greatly influenced by increased axial loads due to overturning. However, assuming a uniform axial stiffness distribution in plan, vertical excitation causes a uniform increase in the axial force response of all columns in the same storey irrespective of their position. An example of interior column failure is the 3-storey parking structure of the California State University at Northridge, a modern structure only 18 months old at the time of the earthquake.<sup>13,14</sup> The structural system comprised a perimeter ductile precast moment resisting frame which was responsible for accommodating the transverse earthquake loads. The internal frame, comprising precast beams and columns, constituted the gravity load resisting system. During the earthquake some of the interior columns suffered total collapse due to compression failure, while the lateral load resisting system did not exhibit signs of distress arising from horizontal earthquake-induced forces.<sup>10,14</sup> Damage to this system was secondary and was due to collapse of interior columns and subsequent inward bending of the lateral force resisting system, which exhibited extremely high rotational ductility,<sup>10,14</sup> as illustrated in Figure 5. Such a failure mode suggests a very substantial increase of the axial forces acting on the gravity system. This was most likely induced by direct action of the vertical component or from possible vertical vibrations of the floor system. This mechanism was also manifested by shear-compression failure in interior columns of a cast-in-place garage in Sherman Oaks.<sup>11</sup> A damaged column of this structure is shown in Figure 6.

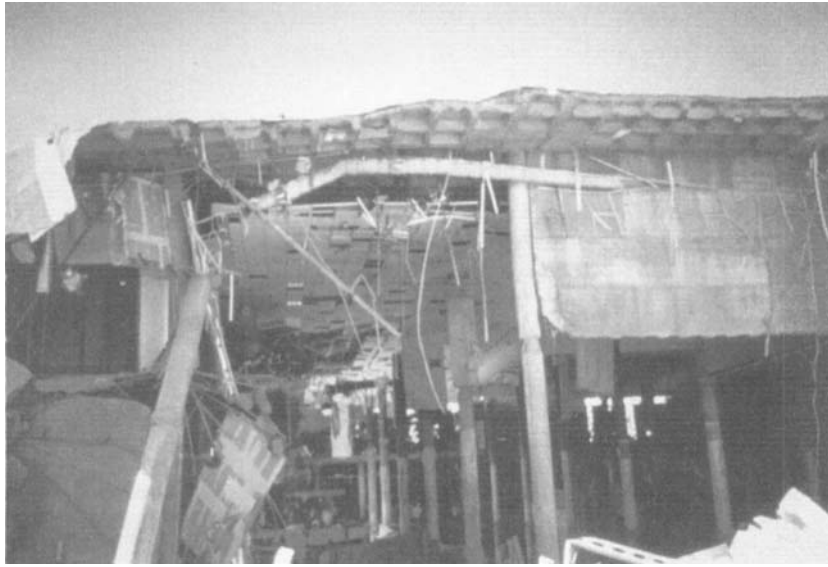
Figure 7. Punching shear failure in waffle slabs of the Bullocks store. Note intact columns and original floor levels. Photograph courtesy of Earthquake Engineering Research Institute

An interesting case of punching shear failure in waffle slabs occurred in the upper two floors of the Bullocks store in Fashion Island Mall. This collapse almost certainly occurred as a result of the high vertical accelerations experienced in the epicentral region which triggered strong vertical oscillations of the flat slab.<sup>14</sup> In the particular structure, the majority of the columns supporting these slabs showed only minor damage which suggests a limited effect of horizontal motion. The failure mode is shown in Figure 7. Punching shear failure was also observed in the Four Seasons Hotel in Sherman Oaks and in the flat slabs supporting a number of timber apartments.<sup>10,11</sup> Moreover, the severe effect of the vertical component on floor oscillations can also be observed in the Northridge Fashion Centre north-west parking structure. The simply supported double-tee floors of this building experienced severe vertical oscillations which resulted in shear cracking as well as total collapse of the floor system.<sup>14</sup> This is illustrated in Figure 8. The mode of damage is a consequence of vertical excitation since the floor system was independent of the lateral load resisting system.

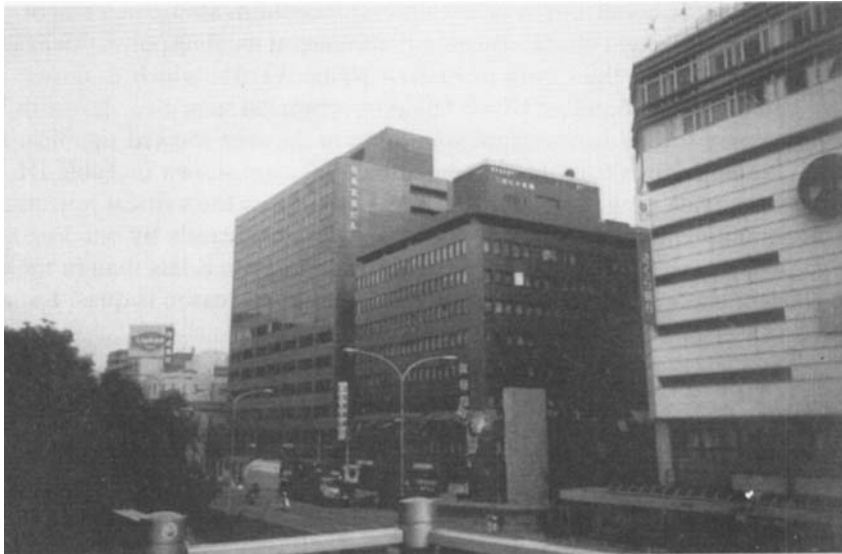
Figure 10. A 10-storey building with a collapsed 3rd floor in Kobe city. No tilt or misalignment of the collapsed block relative to the base is observed

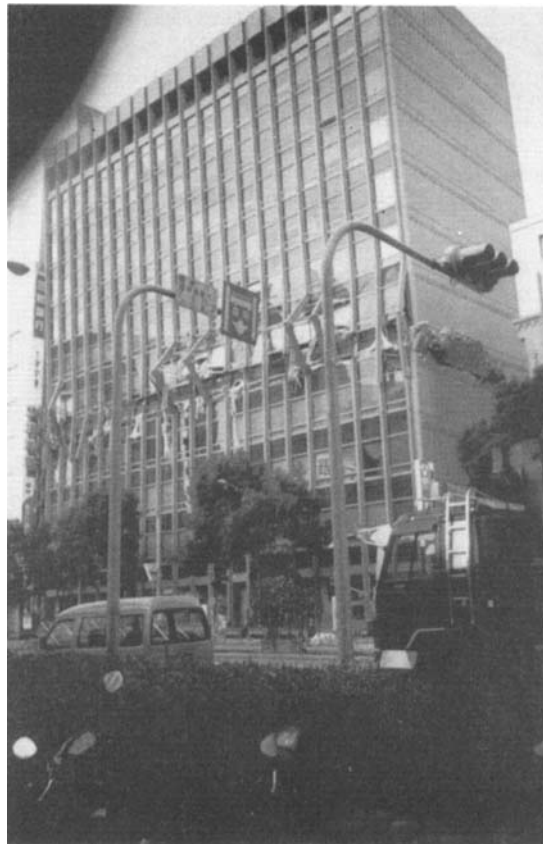
Figure 11. A 12-storey building with a collapsed 5th floor. Note squashing and out of plane buckling of shear wall

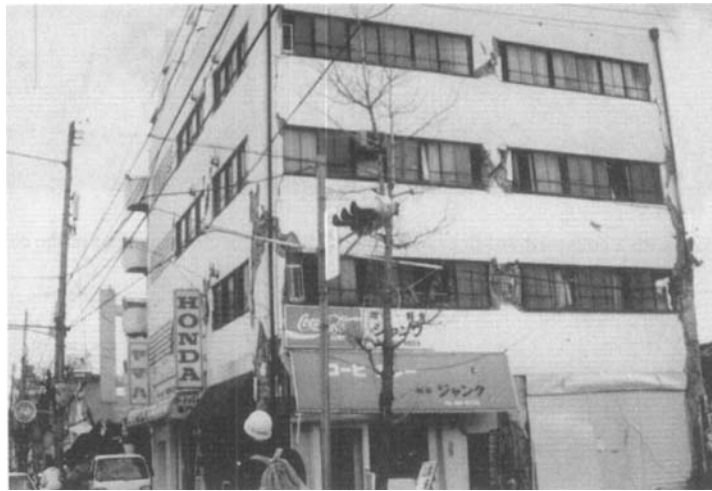
Figure 12. A 4-storey building in Kobe with shear-compression failure in all internal columns. Photograph used with kind permission of Dr Minehiro Nishiyama

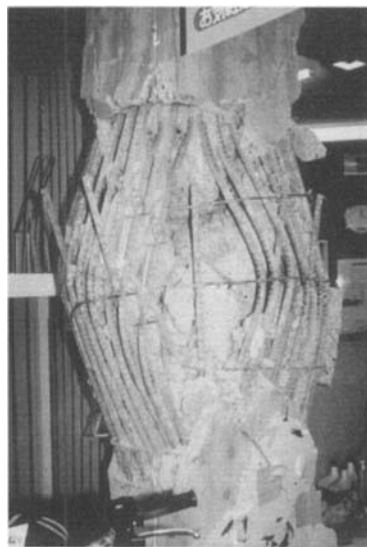
Figure 13. Compressive failure of internal column of the building shown in Figure 12. Photograph used with kind permission of Dr Minehiro Nishiyama

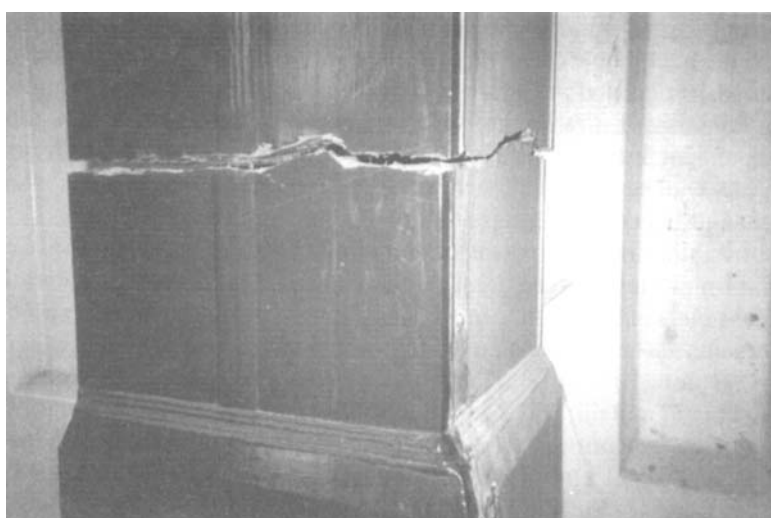
Figure 14. Column brittle tensile failure observed in a steel mega-truss at Ashiya-hama

Of particular interest herein is the failure of members of the mega-truss comprising the structural system of the Ashiya-hama complex. Since the truss system ensures that no bending action exists, observed horizontal

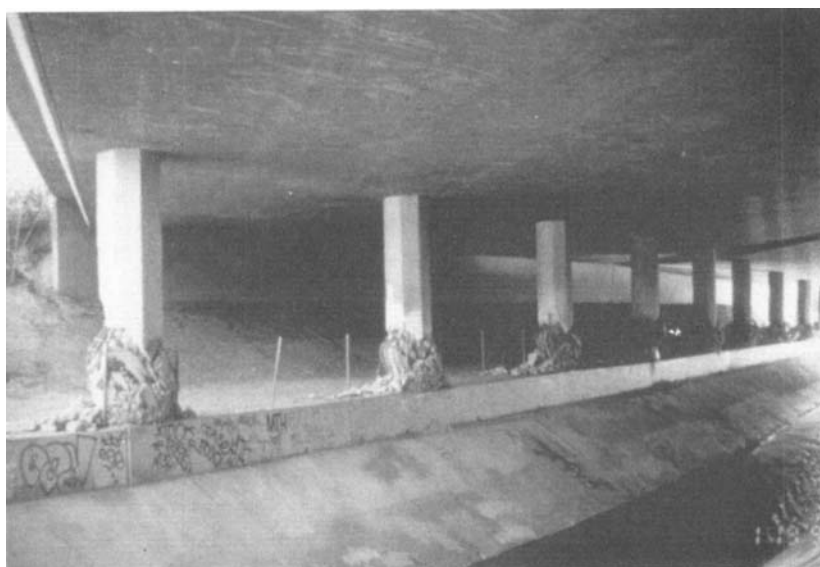
Figure 16. Compression failure and bulging of piers along bent 3. Bull Creek Canyon Channel Bridge. Photograph courtesy of Earthquake Engineering Research Institute

All of the bridge piers at bent 3 (total 10 piers) suffered severe damage at their base. In particular, fractured transverse reinforcement, buckling of longitudinal column bars, core disintegration and significant axial shortening was observed, as depicted in Figure 16. On the contrary, only the two southernmost columns of Bent 2 failed in a similar manner below the transition of hoop reinforcement near the column top. It has been argued that the failure of bent 3 was induced by the formation of plastic hinges at the column base. Also, the presence of a structurally connected wall aligned with the channel and the bent was blamed for reducing the clear span of the piers and hence forcing hinging in the less confined zone.<sup>9</sup>

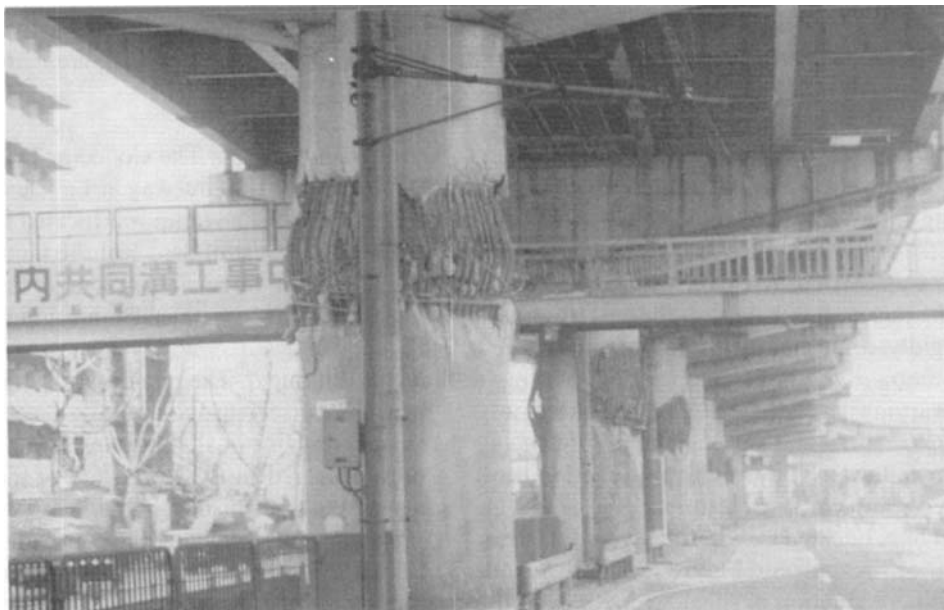
Figure 18. Series of compressive failures along piers of the Hanshin Expressway. Photograph courtesy of EQE International

**3.2.3. Hanshin Expressway.** An analysis of the structure which was discussed in Section 2.2.3 and shown in Figure 18 was undertaken at Imperial College.<sup>16</sup> The failure pattern cannot be attributed with certainty to neither shear nor flexural mechanisms, since the concrete cover spalled symmetrically and longitudinal reinforcement buckled over a small length at mid-height of several piers. In addition, the core concrete was nearly crushed, but did not disintegrate fully. It was this pattern of failure that motivated the Imperial College group to study this particular bridge.

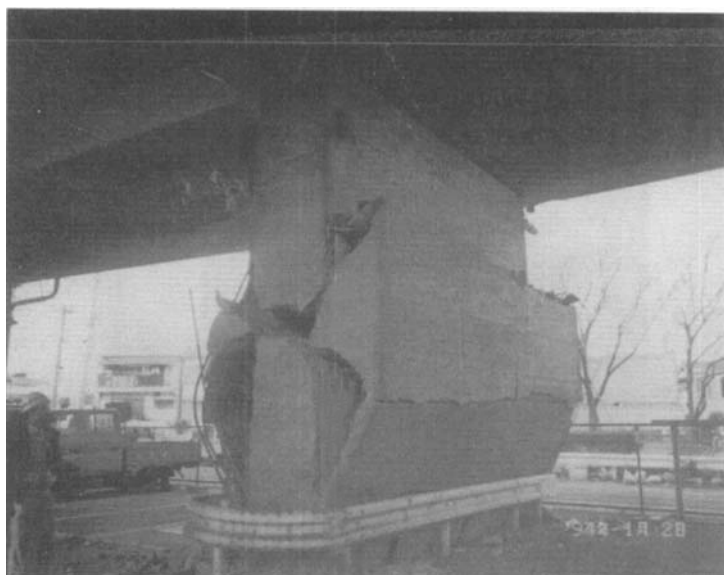
Figure 20. Compressive failure of wall-type pier of Meishin Expressway. Photograph used with kind permission of Professor Atsuhiko Machida

Finally, compression-dominated failure has also been reported for two more bridges, namely the Meishin Expressway and the Second Shinmeyer Overbridge.<sup>19</sup> The former was of continuous cast-in-place construction and consisted of wall-type piers. Several piers suffered compressive failure manifested by bulging and significant axial shortening, as shown in Figure 20. Buckling of longitudinal reinforcement was also observed. The latter bridge comprised continuous steel box-girder superstructure supported on pairs of squat piers connected by transverse beams. The piers of the bridge exhibited an unusual mode of failure manifested by bursting of the pier along the length and fracture of transverse reinforcement. The mode of failure is shown in Figure 21.
